3-3-81
REPORT NO. NADC-77073-30

REAL-TIME X-RAY INSPECTION OF COMPOSITE AIRCRAFT STRUCTURES

December 1978

FINAL REPORT
AIRTASK No. OTR Rework
Work Unit No. GA801

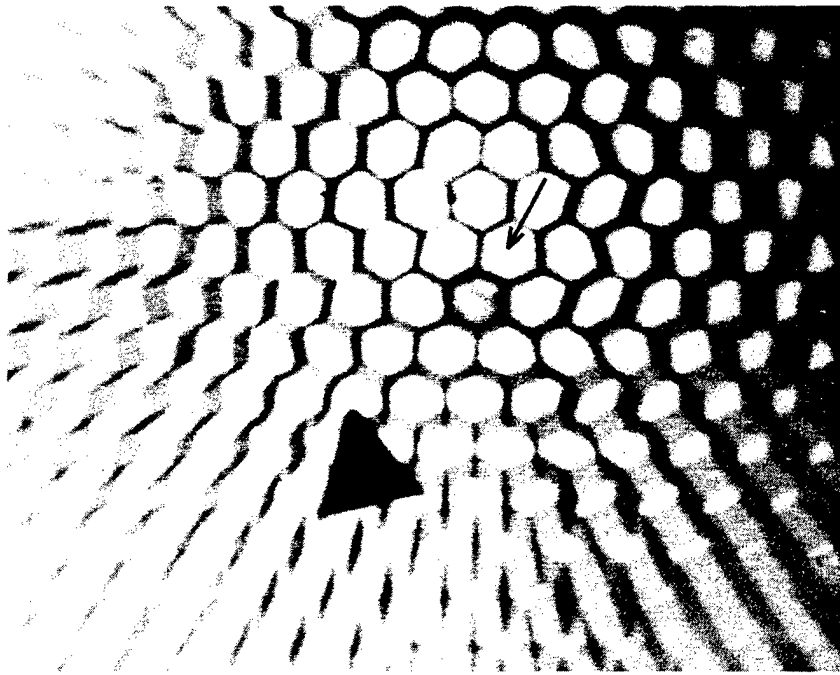
Another common type of composite defect listed on Table 6 is core damage. This can either occur during manufacturing or result from impact or ballistic damage. Figure 13 shows an RTR of a graphite/epoxy sample with a single damaged cell resulting from manufacturing. Another example, Fig. 14, is an RTR of a graphite/epoxy sample with the honeycomb core damaged by impact. These examples illustrate the sensitivity of RTR for detection of core damage even as minute as damage to a single cell.

Figure 13. RTR of a Graphite/Epoxy sample with aluminum honeycomb illustrating damage in a singular core (70kV, 5mA)

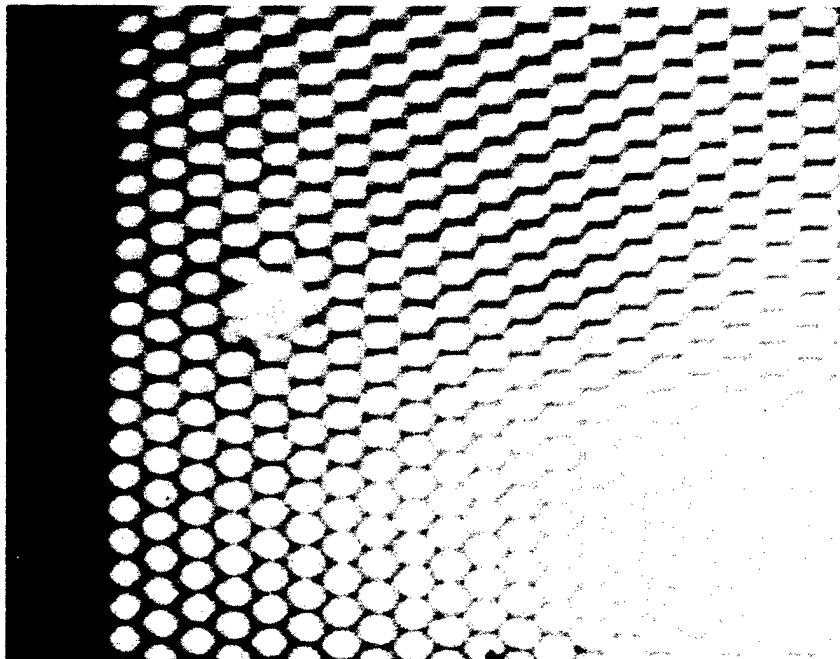
Figure 14. RTR of a Graphite /Epoxy Sample with Aluminum Honeycomb illustrating core damage (70kV, 5mA)

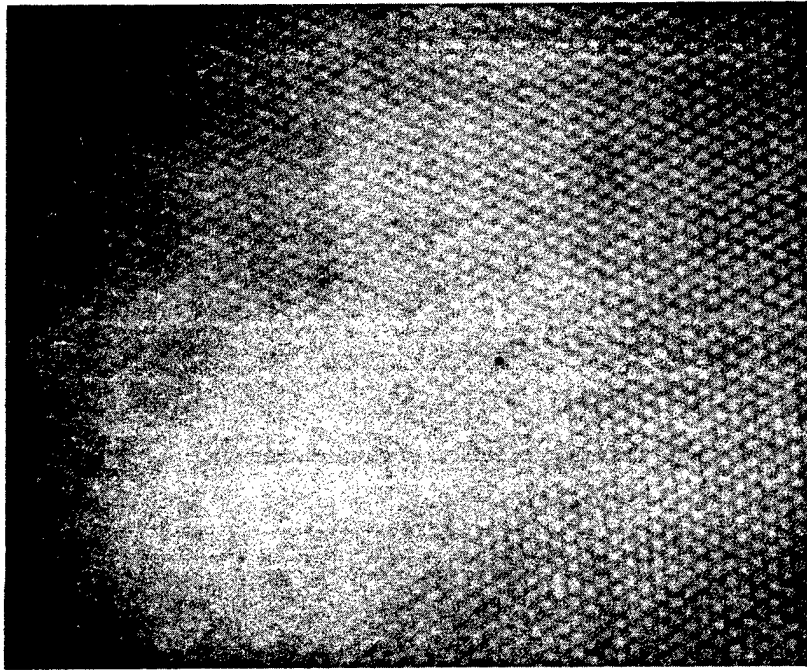
Moisture absorption is a type of damage that results from continuous environmental exposure of the composite structure. This type of damage usually produces erosion, which can subsequently result in failure. Figure 15 is an RTR of a graphite/epoxy sample that contains varying amounts of moisture throughout the piece. The next RTR, Fig. 16, shows where water has collected in the honeycomb cells of a fiberglass/epoxy sample. Moisture absorption is a common problem with aircraft deployed on carriers, which could be easily inspected with RTR for quick detection and immediate assessment.

Figure 15. RTR of a Graphite/Epoxy sample with composite honeycomb illustrating moisture absorption throughout the sample (70kV, 5mA)

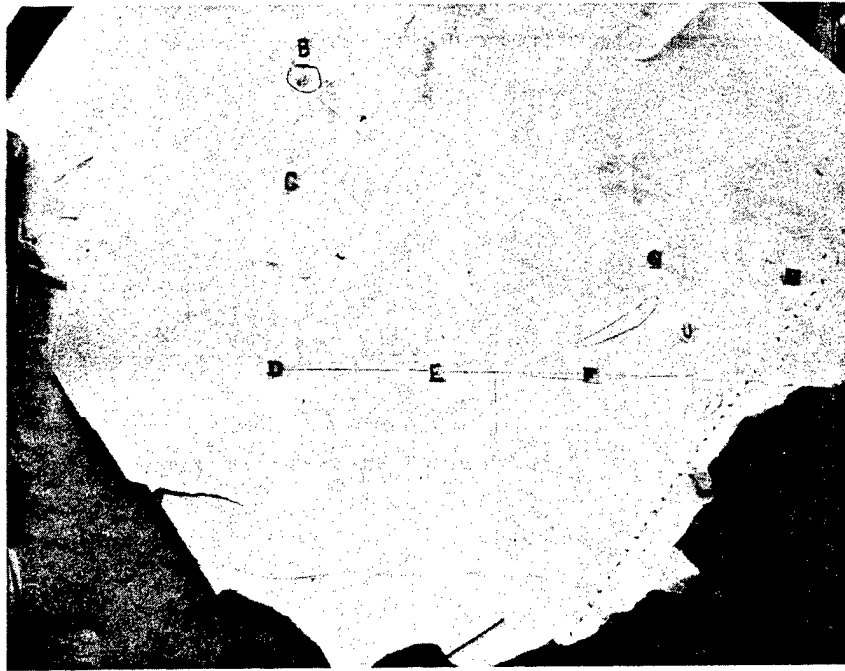
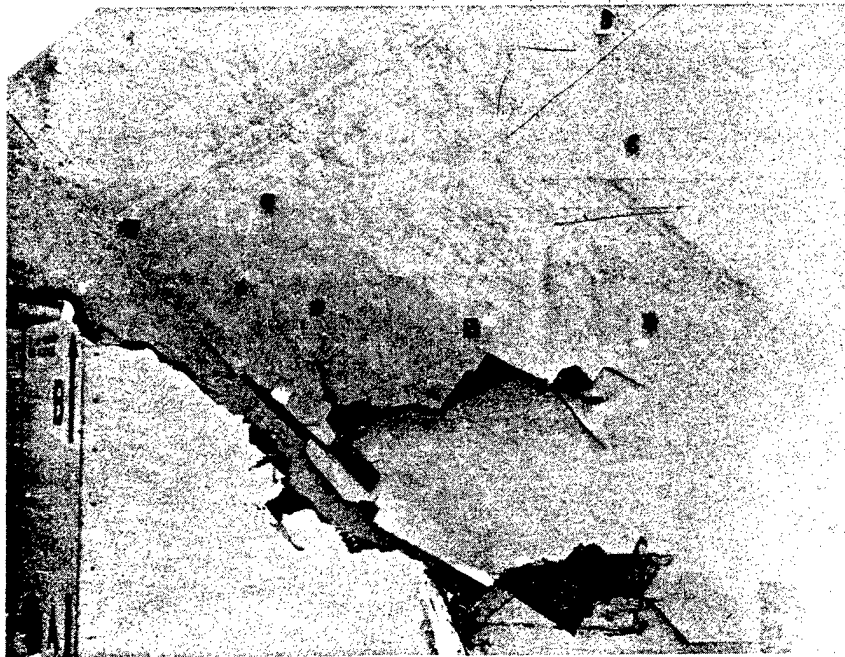
Figures 17 and 18 show the front (x-ray source side) and back (next to RTR screen) of a damaged F-14 stabilizer labelled with lead letters at different areas to identify the area during inspection. The photographs illustrate extensive damage at D, E and F, with no visible damage at C, H and U. Areas B and G contain small nicks that are visible on the surface.

Figure 17. Front Side of a damaged F-14 Boron/Epoxy horizontal stabilizer

Figure 18. Back side of the F-14 horizontal stabilizer

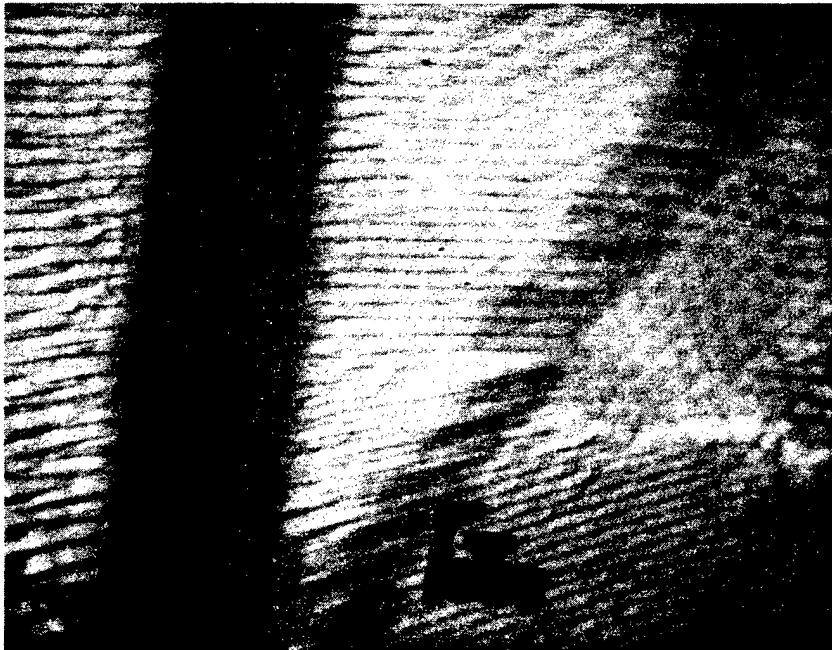
Figures 19, 20 and 21 are the RTR's of areas D, E and F illustrating the extensive skin and honeycomb damage. Figures 19 and 20 of areas E and F indicate extensive core damage and various cracks (light areas). In addition, area D, Fig. 21, illustrates single cell damage similar to the damaged cell produced during manufacturing (Fig. 13). Area U is shown in Fig. 22, with varying amounts of damage indicated in the upper right quadrant. Areas B and G that contained the nicks were inspected, with the small nick at B barely visible on the videomonitor. Although the nick at area G could be seen on the monitor, it was impossible to photograph. The last area, H, was radiographed to show where the composite and metal are bonded. Figure 23, of the area shows the variations in the adhesive bonding the honeycomb structure to the aluminum. Figure 24, another RTR of area H, is a radiograph taken with increased x-ray energy and current to image the metallic area which is not very visible

Figure 20. RTR of area F of F-14 stabilizer illustrating a large crack (indicated by the light area) (65kV, 3.5mA)

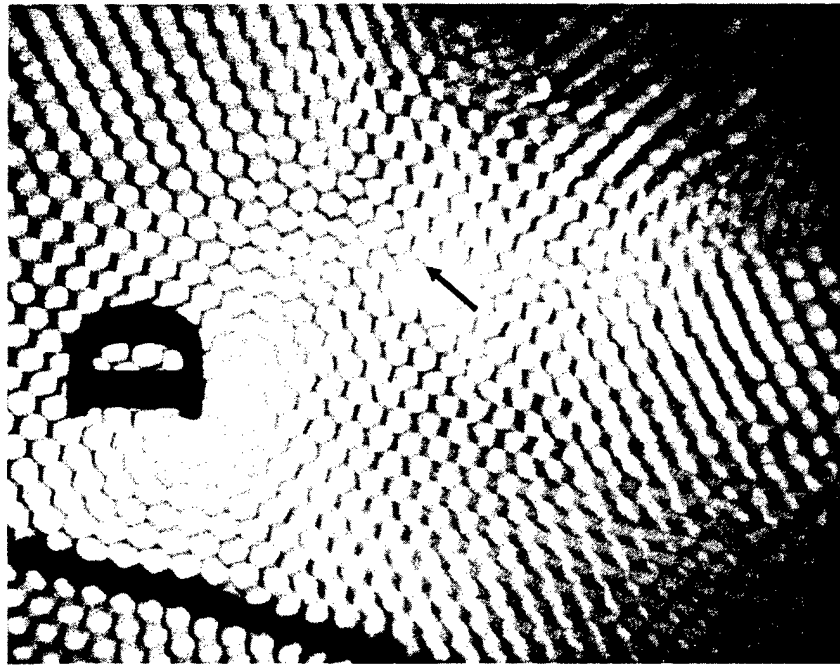
Figure 21. RTR of area D illustrating a large area of crushed honeycomb in the right corner. In addition a singular core indicates core damage similar to the type in Figure 13. (65kV, 4mA)

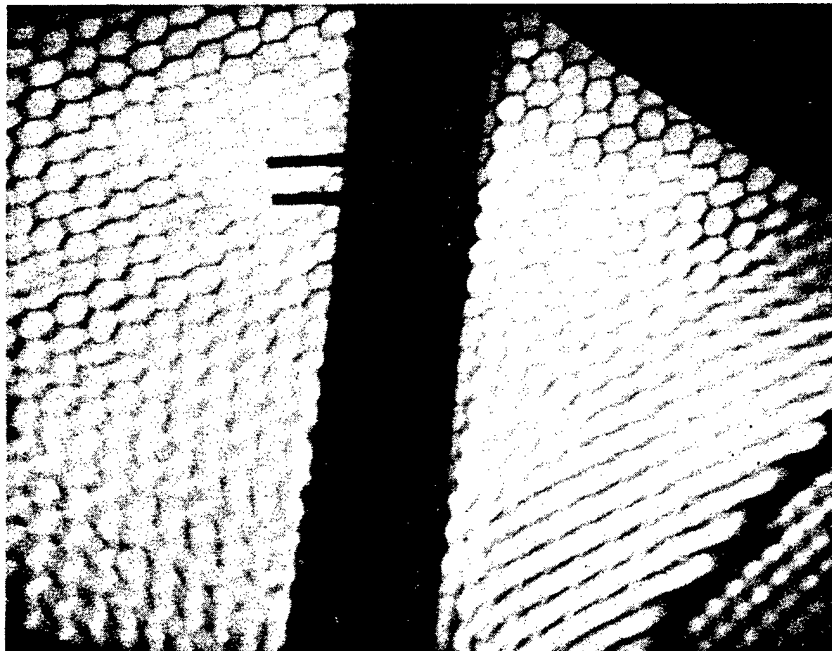
Figure 22. RTR of area U illustrating damage that is not visible on the surface (64kV, 4mA)

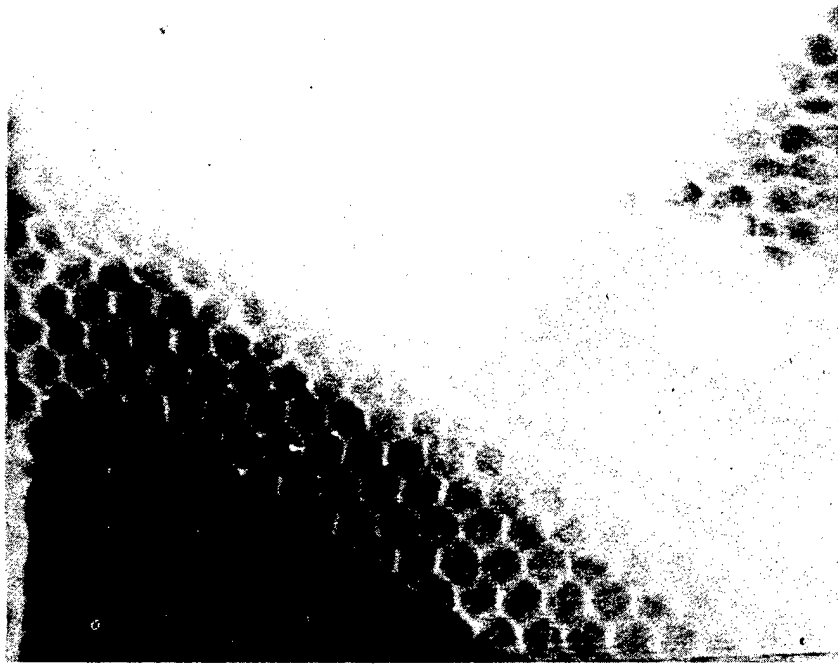
Figure 23. RTR of area H illustrating where the honeycomb is bonded to the aluminum honeycomb. The white areas indicate excessive adhesive (80kV, 4mA)

in Fig. 23. This illustrates an inherent feature of real-time radiography that allows continuous exposures at increasing x-ray energies to highlight differing materials. This would require multiple film exposures to accomplish the same singular real time inspection.

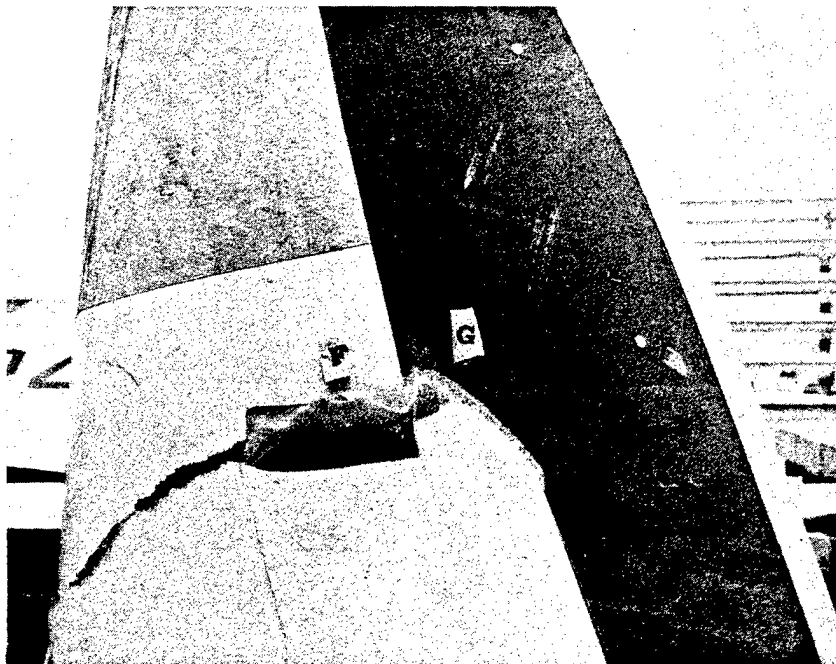
Figure 25. Damaged Fiberglass/Epoxy F-14 Radome containing a fiberglass honeycomb core

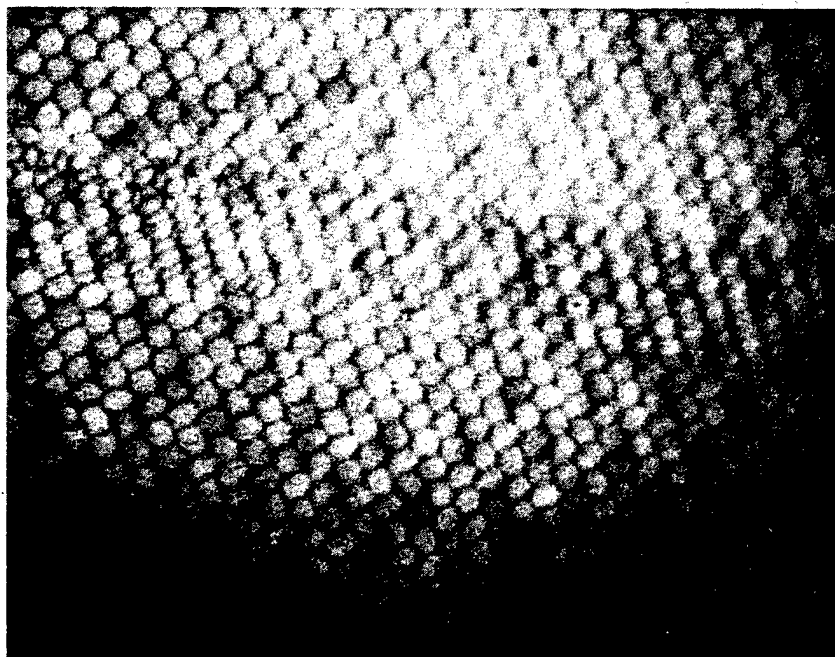
Figure 26. RTR of area F of the F-14 radome illustrating the cracks (white areas) and damaged honeycomb. The variations in the RTR indicate the porosity in the honeycomb. (60kV, 3.6mA)

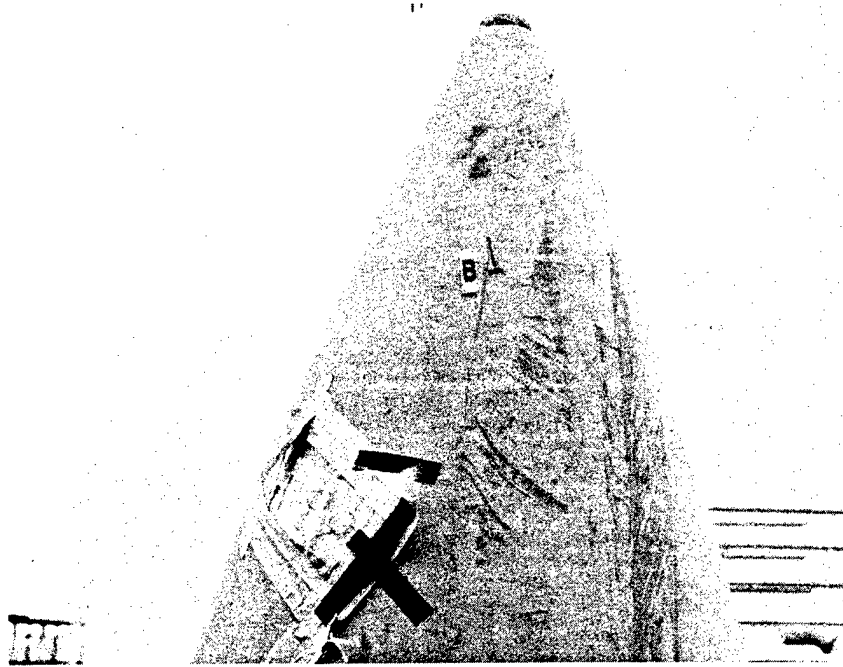
Figure 27. Damaged F-14 radome with a nick visible at area B

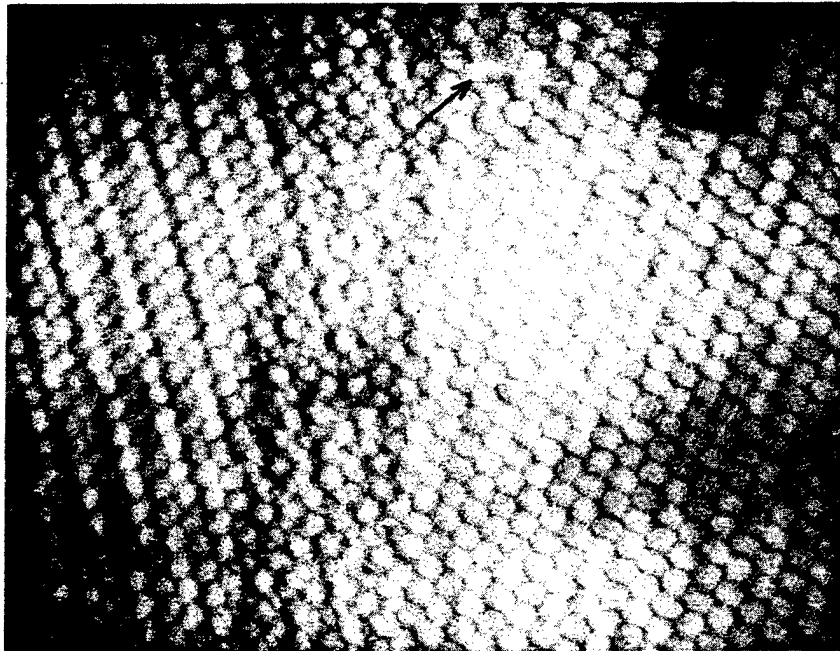
Figure 28. RTR of area B of F-14 radome illustrating the nick
(60kV, 3.6mA)

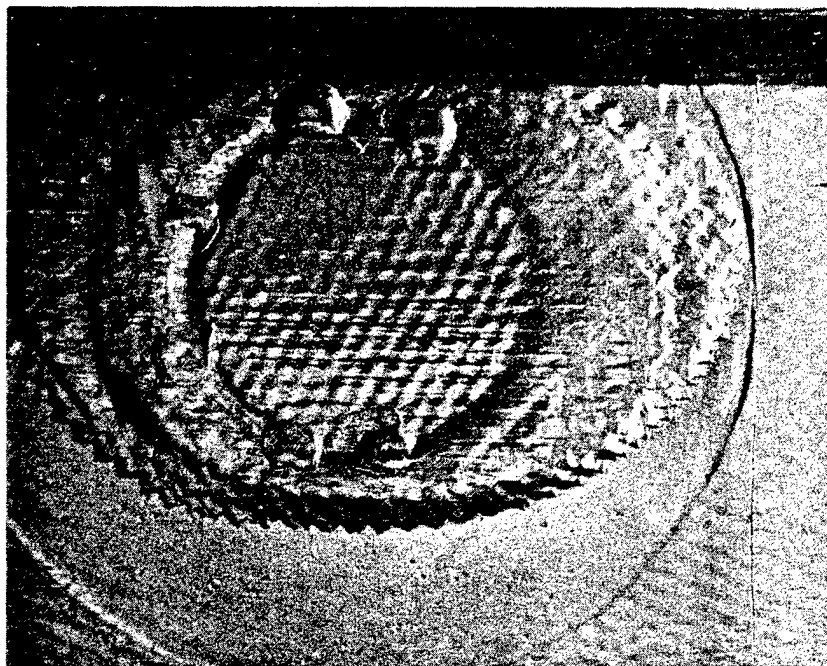
The last example inspected by direct RTR imaging was not for defects or damage, but repair verification. An S-3A spoiler recently repaired by the NARF, Alameda and NADC, Warminster was inspected at SAI to illustrate the feasibility of real-time radiography to image the repaired area and to inspect the splice of the core plug and also the core filter. Fig. 29 shows the repaired area of the graphite/epoxy S-3A spoiler. The RTR, Fig. 30, clearly illustrates the splice, plug, and filler. This radiograph illustrates another feature of the RTR system; the ability to electronically enlarge the image on the videomonitor. This was very advantageous when inspecting the splice and was shown to be superior to film radiographs, because of the ease of viewing the area. Therefore, utilization of RTR for this application would allow inspection to immediately verify the condition of the repair.

Figure 29. Repaired area of an S-3A graphite/epoxy spoiler

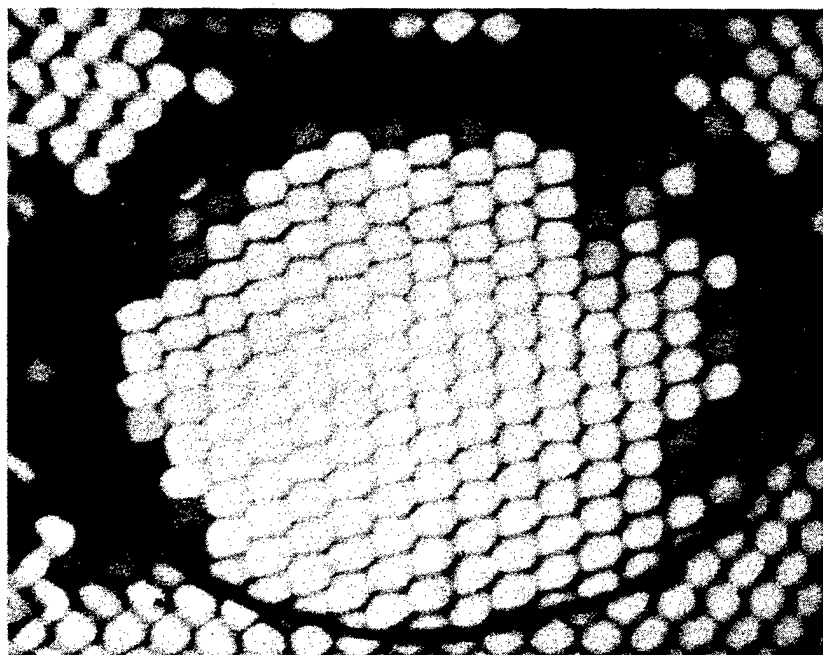
Figure 30. RTR of repaired area illustrating splice and filled core (70kV, 5mA)

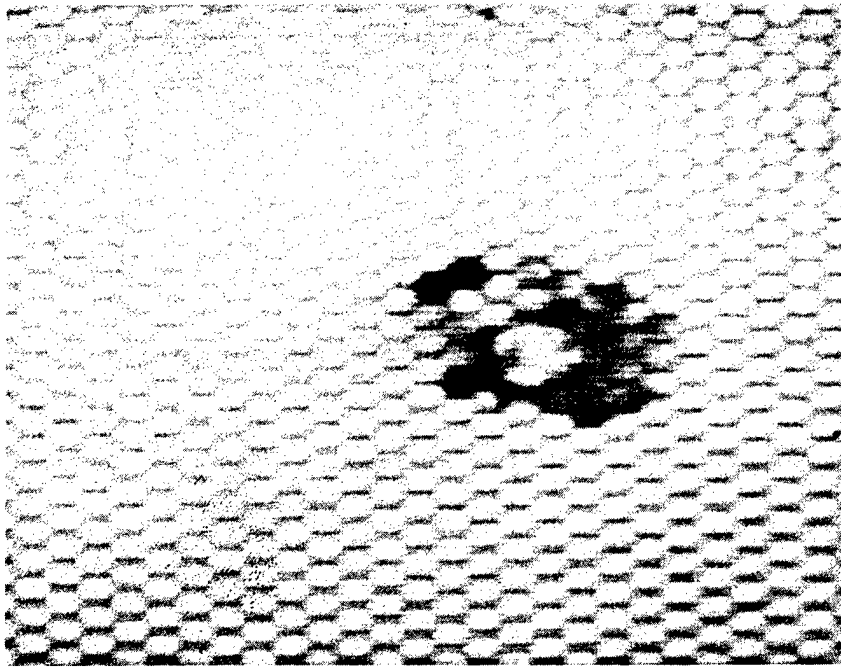
The first sample tested with the system is shown in Fig. 37. This is a graphite/epoxy sample with aluminum honeycomb that was hit with a hammer to produce debonds and delaminations. A 1/4 inch hole was then drilled and the penetrant was forced into the area. Figure 38, the RTR, shows where the liquid has flowed throughout the area illustrating debonds or delaminations. The next RTR, Fig. 39, shows an electronic video enlargement of the same area, showing areas where the liquid is not in the honeycomb, thus indicating that the liquid has flowed in between the graphite/epoxy layers.

Figure 38. RTR of the damaged area illustrating where the penetrant has flowed into the honeycomb and possibly between the laminations indicating debonds and delaminations (65kV, 5mA)

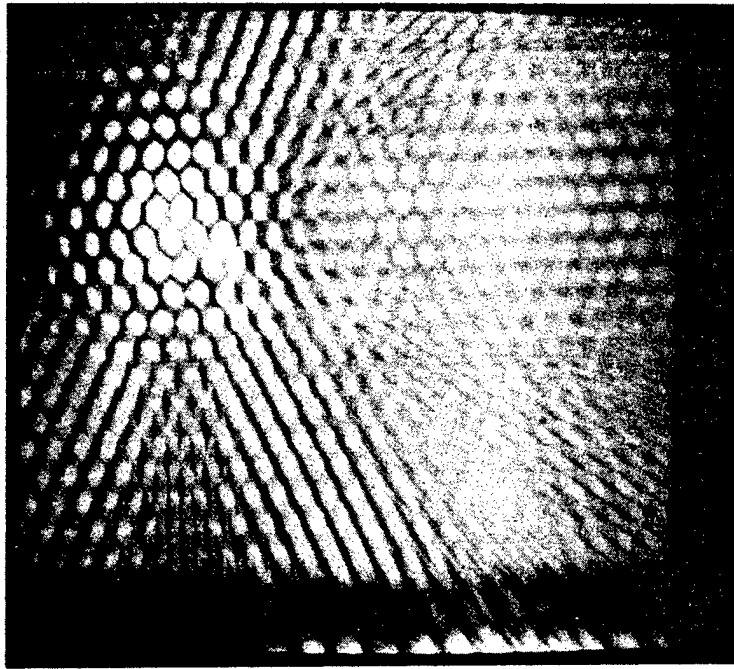
Figure 41. RTR of the damaged section, with no visible indication of damage. The light area is the $\frac{1}{4}$ inch drilled hole (65kV, 5mA)

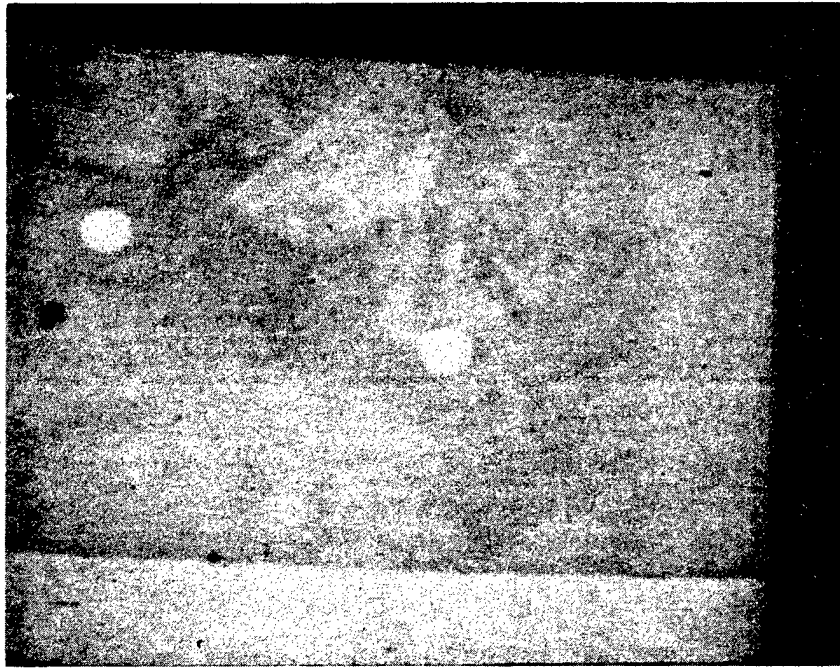
Figure 44. RTR of areas illustrating where the liquid has flowed into the delaminations (65kV, 5mA)

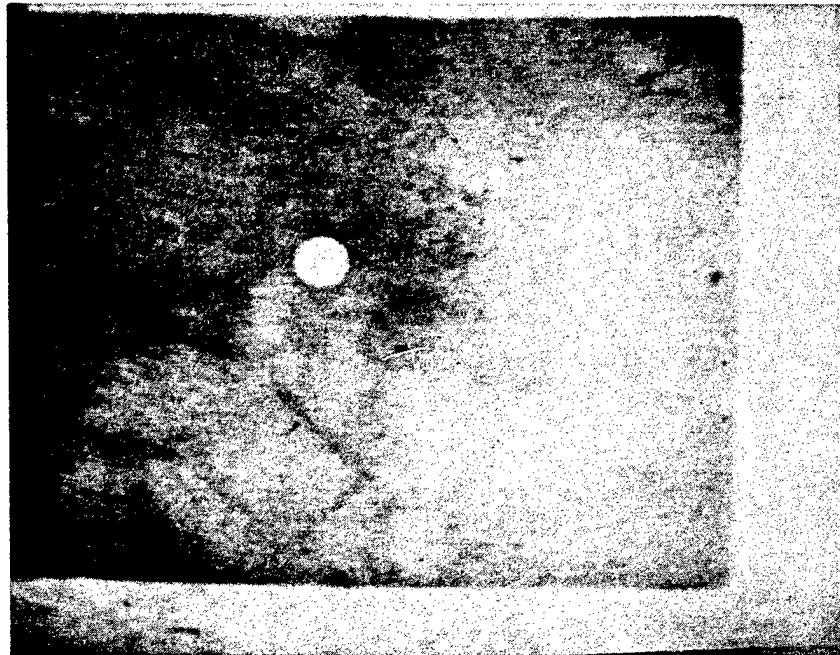
Figure 45. RTR illustrating excessive delaminations throughout the area, indicated by the large amount of the penetrant in the area (65kV, 5mA)
